ELRS Receiver Test

Transmission Quality with Radiomaster TX16s external ELRS module, 100 mW

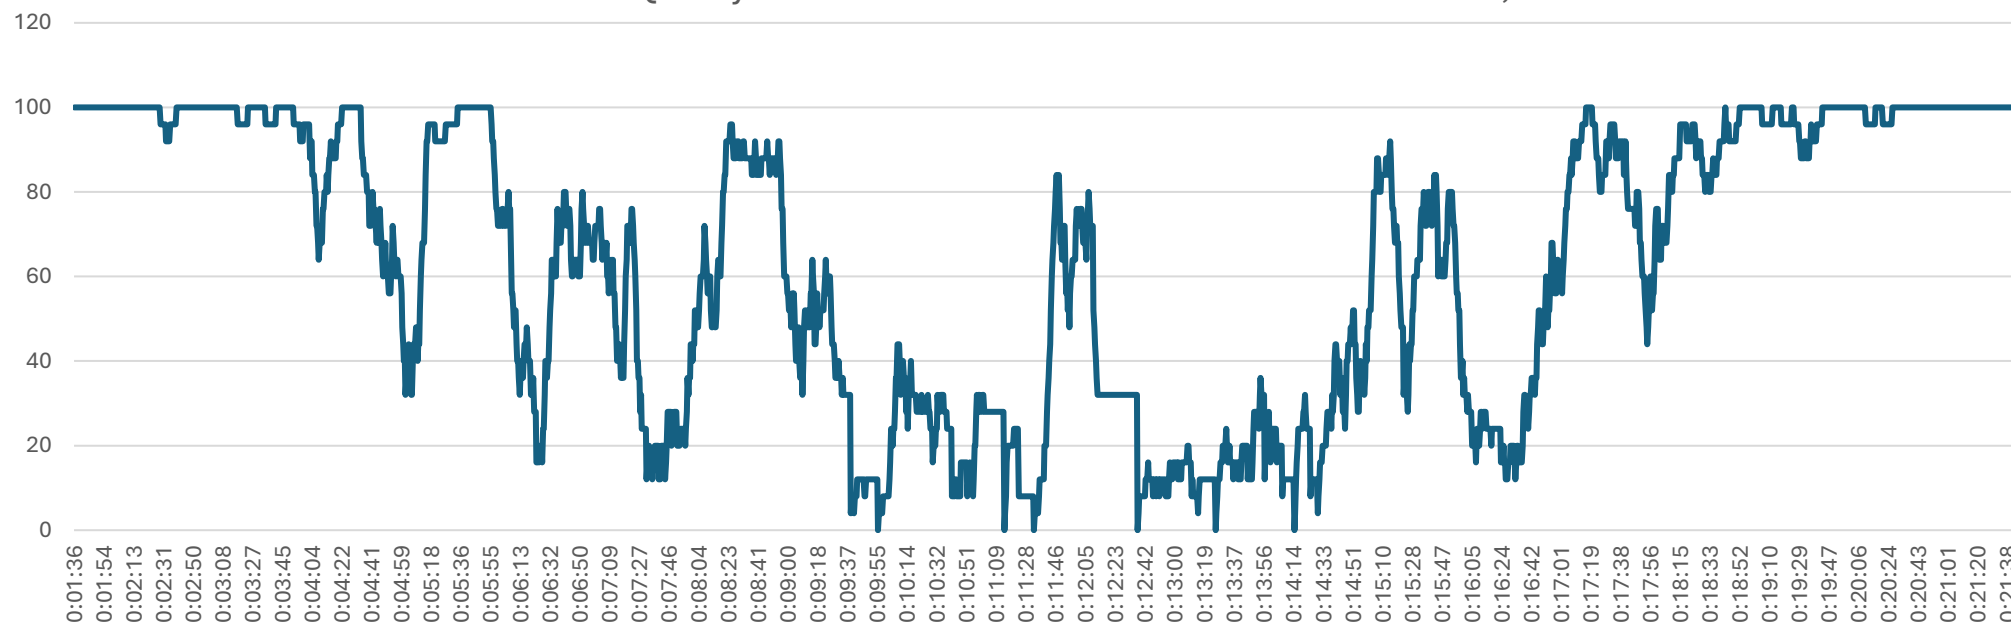
From the video it appears that control was maintained throughout the test. When Transmission Quality dropped to zero, it was only momentary.

Delayed control responses
No control response

Walking away from plane with Radiomaster TX16s to "school," then walking back - lots of trees in signal path. 100 MHz full packet rate.
